Montecito Ranch

GEOLOGICAL RECONNAISSANCE REPORTS

GEOLOGICAL RECONNAISSANCE AND REFRACTION SEISMOGRAPH INVESTIGATION PHASE I OF GEOTECHNICAL INVESTIGATION MONTECITO RANCHO, RAMONA, CALIFORNIA

> May 1, 1989 S.E.A. 88208-01

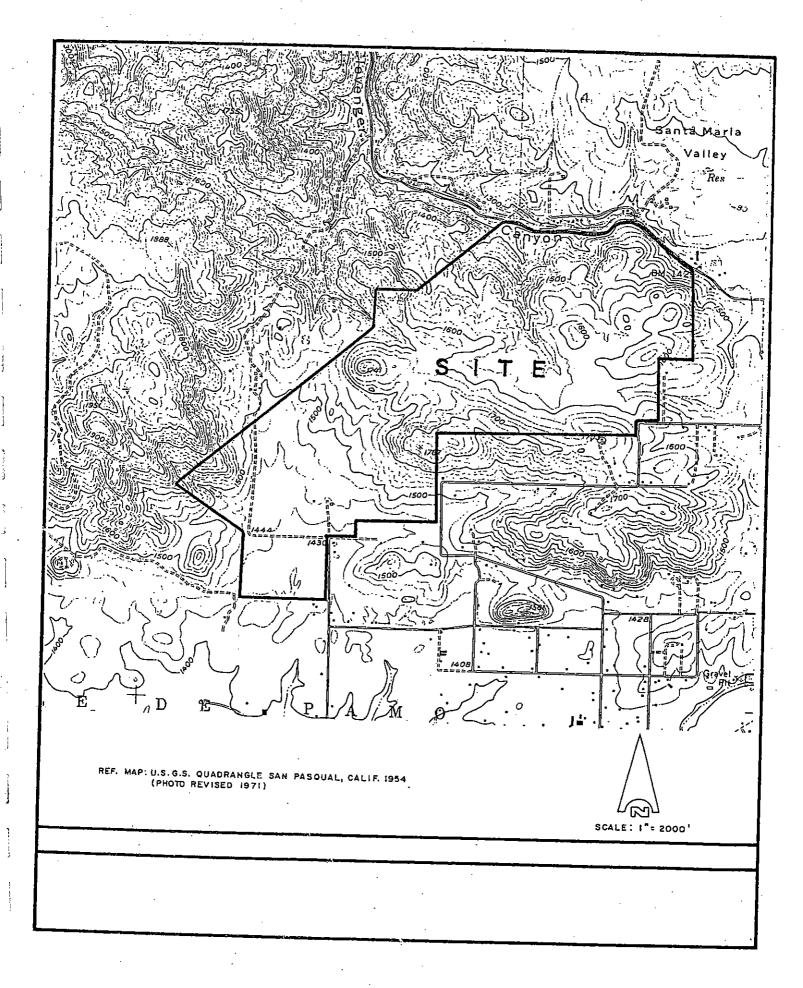
Four geologic formations and four surficial material types were observed at the site. The geologic formations include the Bedford Canyon Formation, San Marcos Gabbro, Green Valley Tonalite, and Woodson Mountain Granodiorite. The surficial materials consist of fill, topsoil, alluvium, and slopewash (or colluvium) deposits. Each of the soil and geologic conditions encountered is discussed below in order of decreasing age. The estimated areal extent of each geologic formation and surficial soil unit (with the exception of topsoil) is shown on the Geologic Reconnaissance Map, Figure 2.

San Marcos Gabbro, excavations exceeding approximately 5 feet in depth into less weathered and fractured portions of the rock, will likely require blasting. Loose boulders on steep slopes may also pose a potential for rockfalls in certain areas (see Figure 2).

Woodson Mountain Granodiorite (Kgw). This Cretaceous-aged intrusive rock occupies the south-central and southwest portions of the site and is characterized by outcrops of light gray, resistant boulders and solid "knobs" of bedrock. This is typically the least fractured and weathered bedrock unit on the property, and is likely to exhibit nonrippable conditions in excavations at shallow depths. Localized areas, especially on the steeper south-facing slopes of the central ridge, may also pose a potential for rockfalls (Figure 2).

Alluvium (Qal). Soils of alluvial original occur at the base of canyons or valleys throughout the site, but are especially prevalent within the southwestern portions adjacent to the Santa Maria Valley (see Figure 2). The alluvial deposits are often difficult to distinguish from slopewash soils, and typically consist of poorly consolidated clayey or silty sands. Development within these areas will require remedial grading as recommended in the concluding sections of this report.

Surface groundwater was noted in the steep, oak-forested canyon in the northern central portion of the site (see Figure 2). A succession of spring-seeps was observed between approximate elevations 1,350 feet MSL and 1,550 feet MSL in this drainage. This canyon may drain aquifers developed within the above-described fracture systems that converge a short distance to the south. Groundwater from the major fracture systems may seep along cross-fractures into this drainage. Because of the network of fractures in proximity to natural structural and topographic catch-basins, a substantial groundwater resource may exist, which could possibly be developed for on-site use. Please note that the potential

Portions of the subdued topography considered favorable for development are downslope from potential rockfall areas (Geologic Map, Figure 2). These potential rock fall areas exist both on and off site. Future studies should address the potential for rockfall, after development plans are formulated. Where rockfall potential is considered to be a significant risk, typical mitigative measures consist of loose rock removal, rock pinning, rock grouting, or constructing protective devices, such as earth berms or fences.
